# TERRY CORPORATION

## REPORT OF POTENTIAL SAFETY HAZARD, 10CFR21 (PART 21 OF TITLE 10 OF THE CODE OF FEDERAL REGULATION)

PART NAME Rev. Chamber Lock Plate Screws QUAN. \_\_\_\_\_

TITLE  
REVERSING CHAMBER FASTENING  
CCS

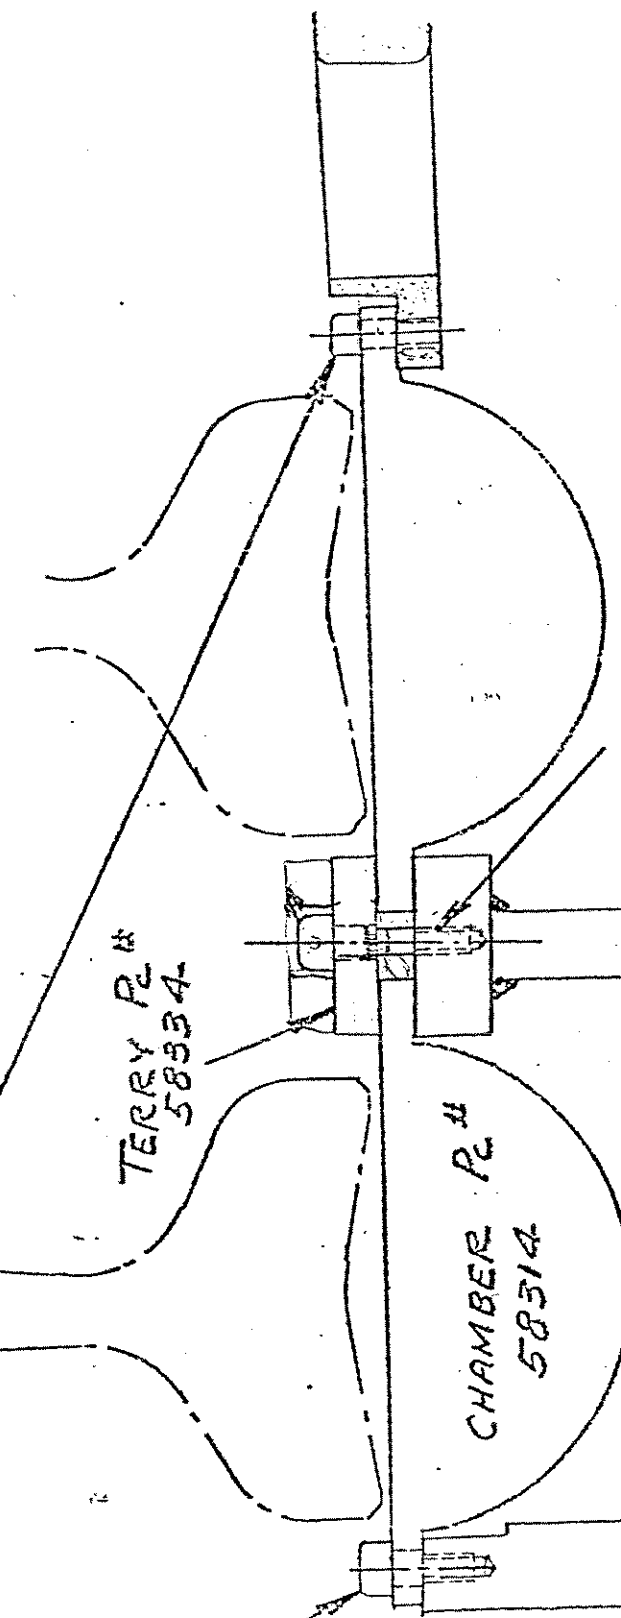
DRAWING NO. HW-12877

DESCRIPTION OF POTENTIAL SAFETY HAZARD OR NON-COMPLIANCE: \_\_\_\_\_  
Recent breakage of lock plate screws at Peach Bottom coupled with attached telex from SNM indicates a design problem which could cause reversing chambers to break free and affect operation of HPCI units.

DETAILED INFORMATION I RECIEVED FROM HAMAOKA SITE.  
TWO OF THREE SCREWS OF ONE CLAMPING PLATE WERE BROKEN AT SCREW  
HEAD AND THE CLAMPING PLATE WAS LOOSE. THEN, TOSHIBA AND CHUBU  
ELECTRIC CHECKED ALL DYNA THREDS.  
ON LOOSING THESE SCREWS, ALL SCREWS ( CLAMPING PLATE SCREWS  
(SCREW LENGTH: 32MM), REVERSING CHAMBER RING SCREWS (SCREW LENGTH:  
25MM) AND CASING SIDE SCREWS (SCREW LENGTH: 22MM) )  
WERE BROKEN AT A POINT OF 10 - 15MM FROM THE SCREW END. THESE  
BROKEN POINTS ARE NEARLY AT THE END OF THE HOLE IN THE BOLT END.  
WHAT DO YOU THINK IS THE CAUSE AND IS IT O.K. TO REPLACE THE  
DYNA THRED ( AS YOUR ADVICE OF 12-19-77 TELEX )?  
WHAT DO YOU THINK OF THE OTHER HPCI TB.S IN JAPAN MUSTWE EXCHANGE  
ALL THESE SCREWS?  
PLS RE-CHECK YOUR BASIC DESIGN AS TO USING THE DYNA-THRED.  
TOSHIBA HAS COMPLAINED TO S.N.M. THAT HAMAOKA NO.2 AND TEPCO NO.5  
HPCI TB.S' SCREWS SHOULD BE EXCHANGED TO NEW SCREWS. PLS ADVISE

ENGINEERING EVALUATION & RECOMMENDATION: Does not constitute a reportable safety hazard.  
A design improvement is required to eliminate breakage of screws #DT5U066 shown on attached drawing HW-12877.  
Engineering to devise a retrofit kit for field modifications of all affected units. Upon availability of kits, customers are to be notified of the design improvement and correction procedure.
