INITIAL REPORT 10CFR PART 21 REPORT OF A POTENTIAL SAFETY HAZARD

Subject: 10 CFR Part 21 Report #39

FINAL REPORT 10CFR PART 21
REPORTING OF DEFECTS AND NON-COMPLIANCE

PART NAME: Nut, Lock-Flexloc Reg Hgt.

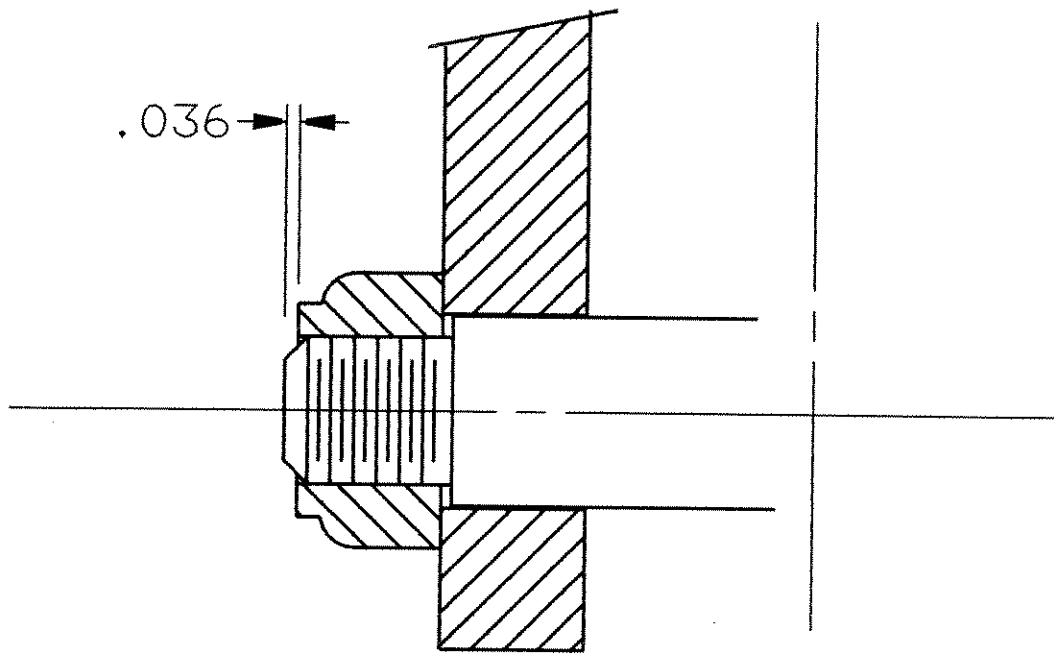
REGULAR NUT

To provide 100% assurance that the locking portion of a nut would be fully engaged with threads of the mating linkage pin would require nut FLEXLOC (thin) DRESSER-RAND part number 75232A06 as shown on attachment #2. The regular series FLEXLOC nut does not provide full thread engagement of the locking feature, based on nominal part dimensions as shown on attachment # 1.

DRESSER-RAND P/N 75233A06
SPS-FLEXLOC NO. 21FA616

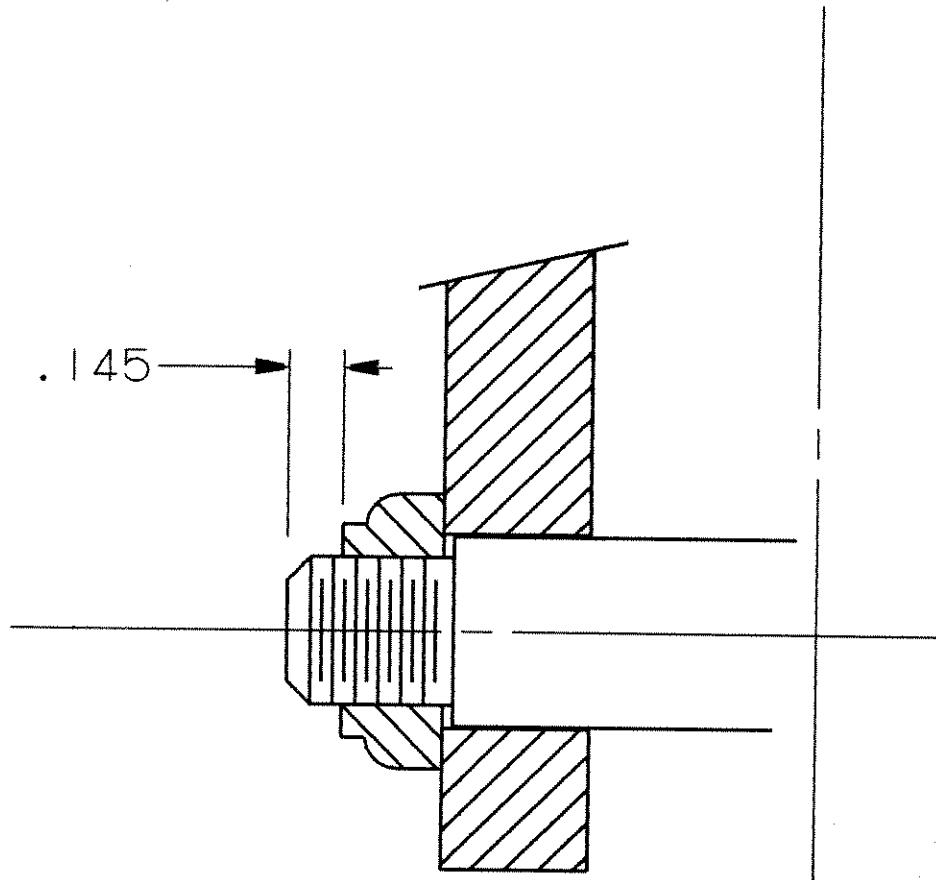
THIN NUT

DRESSER-RAND P/N 75232A06
SPS-FLEXLOC NO. 21FK616

During a seismic event or adverse vibration condition the locking force could be questionable. With the thinner nut DRESSER-RAND part number 75232A06 would provide a better design because of the greater assurance of full locking feature engagement by meeting the design requirements for the above conditions.

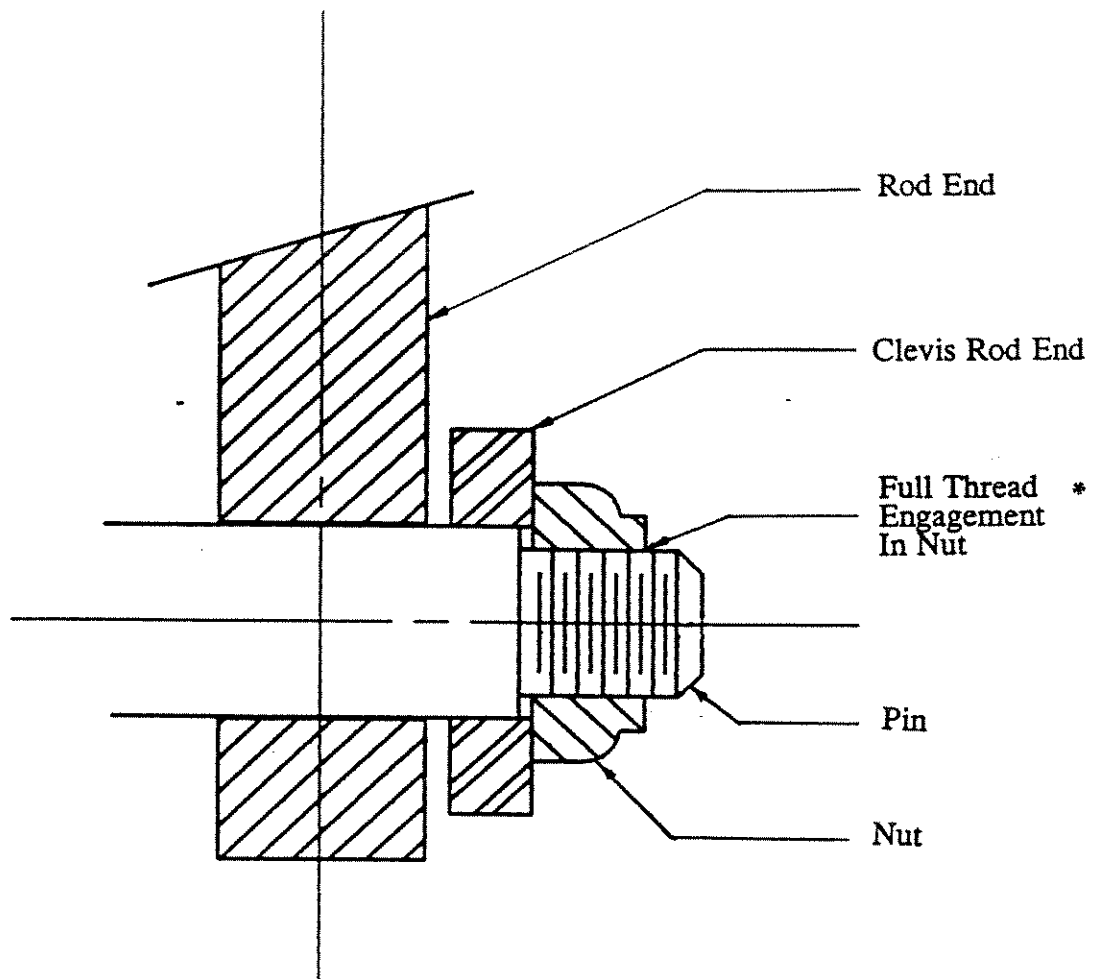
TYPICAL ASSEMBLY

*** All threads in the locknut must be engaged by the threads on the pin. Amount of exposed threads will vary with application.**

Inspect all applications of locknuts on the control linkage for full thread engagement in locknut.
