TERRY CORPORATION

DESIGN IMPROVEMENT
DI 9

Because of damage occurring to the turbine governor valve stem gland air seal piping connection, prior to turbine installation, it is recommended that a support bracket be fabricated and installed to support piping connections in position as shown on the attached photograph.

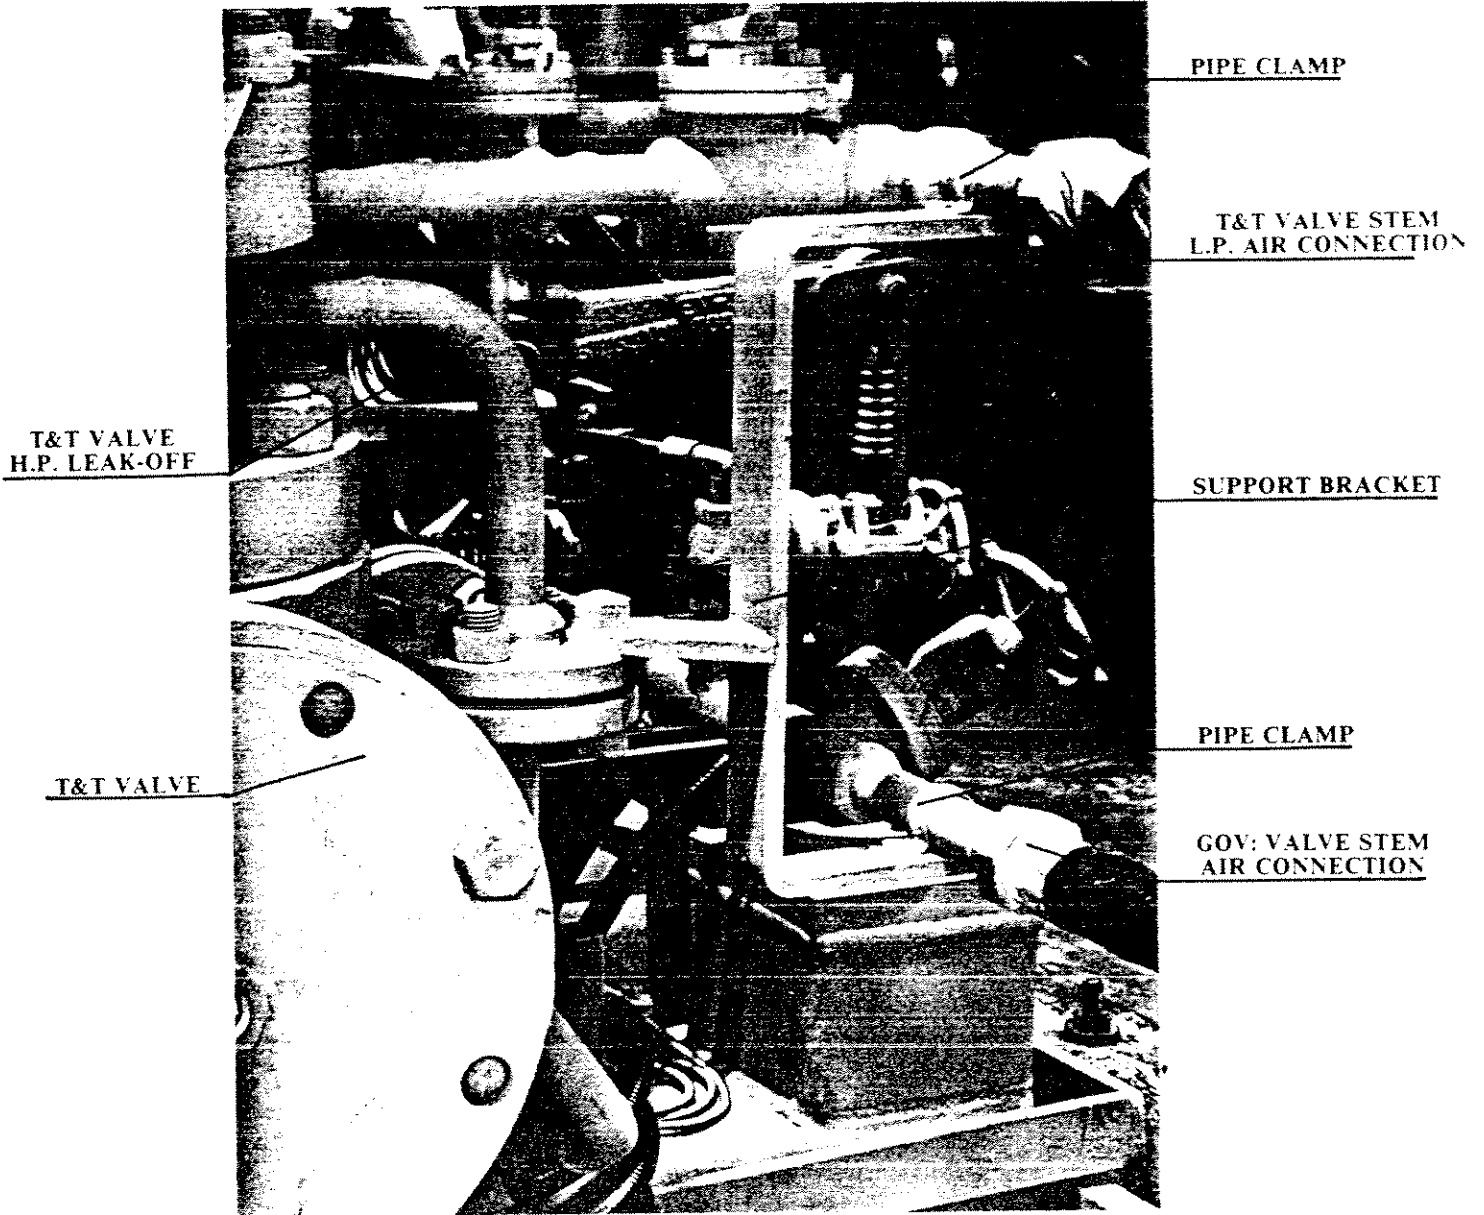
D.I. NO. 9

FIG. 1
GLAND CONTAINMENT AND DRAIN PIPING SYSTEM REF DWG 89779C
SUPPORT BRACKET FOR TURBINE TRIP AND THROTTLE VALVE STEM
LOWER PRESSURE GLAND LEAK-OFF CONNECTION AND THE TURBINE
GOVERNOR VALVE PLUG STEM GLAND LEAK OFF

The support bracket is fabricated from flat bar stock (ASTM 108) 3/8 ins. thick by 2 ins. wide. The photo print shows the construction of the support and the use of pipe clamps to secure the piping connections.

Anchoring of the support bracket is achieved by bolting to the T&T valve stem high pressure leak-off piping flange.

The support bracket must be fabricated and installed to each individual turbine assembly because of minor variations in pipe routing.
